Walla Walla River Basin Fish Screen Evaluations

Burlingame and Little Walla Walla Sites

**Technical Report
2001**

PNNL-13665

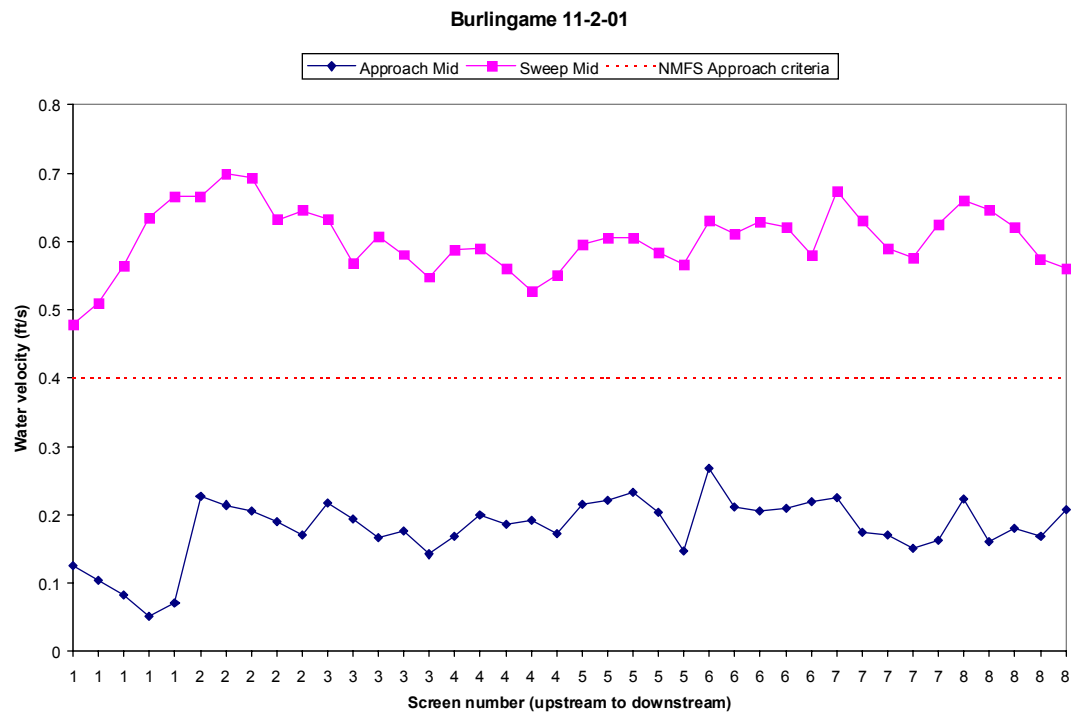
Velocity measurements indicated that all of the approach velocities met NMFS criteria on November 2 (Figure 4). Sweep velocities were always higher than approach velocities, and the water velocity in the bypass was higher than the sweep velocity in front of the screens (Table 1).

Figure 4. Approach and sweep velocities at the Burlingame fish screen site on November 2, 2001. Screen bay 1 is blocked and does not have a drum screen in it. The red line at 0.4 feet/sec denotes the NMFS criteria for fish screen approach velocities.

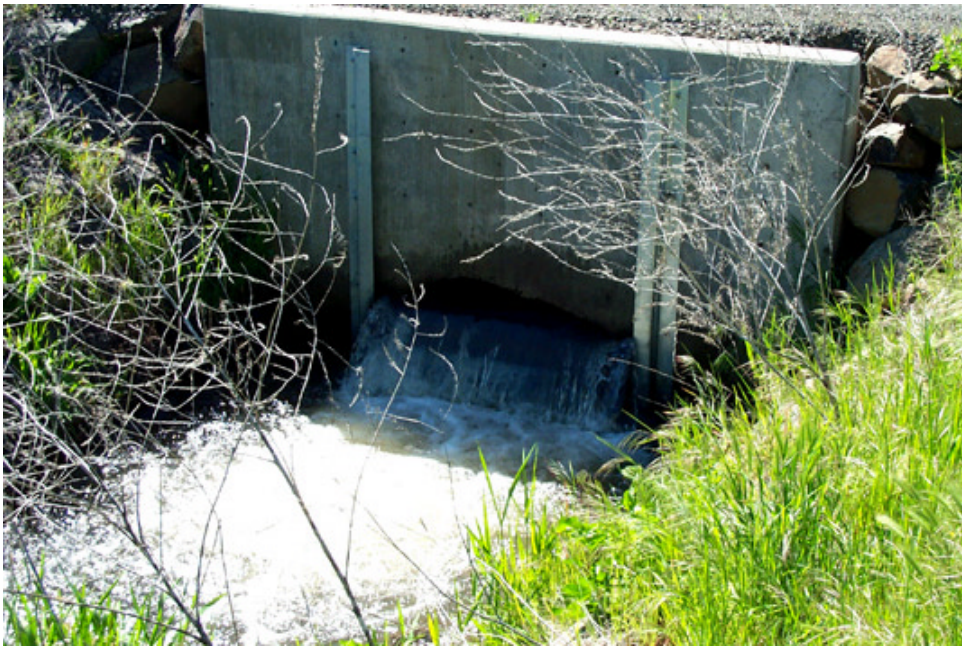
The NMFS established a number of guidelines and criteria concerning bypass conduit design and outfall conditions (NMFS 1995). These criteria state that, “for diversions 25 cfs and greater, the required pipe diameter shall be greater than or equal to 24 in. (61 cm) and that the minimum depth of open-channel flow in the bypass conduit shall be greater than or equal to 9 in. (23 cm), unless otherwise approved by the NMFS.” The bypass outfall at Burlingame is an open channel with approximately five four-by-six boards installed to back up the outfall at the culvert and limit adult salmonid movement upstream into the screen forebay (Figure 5). Water ran freely over the bypass weir in both months, and the water level at the outfall discharge was greater than or equal to one foot in both months, which was well within NMFS criteria.

Figure 5. Bypass drop structure at the Burlingame fish screen facility.

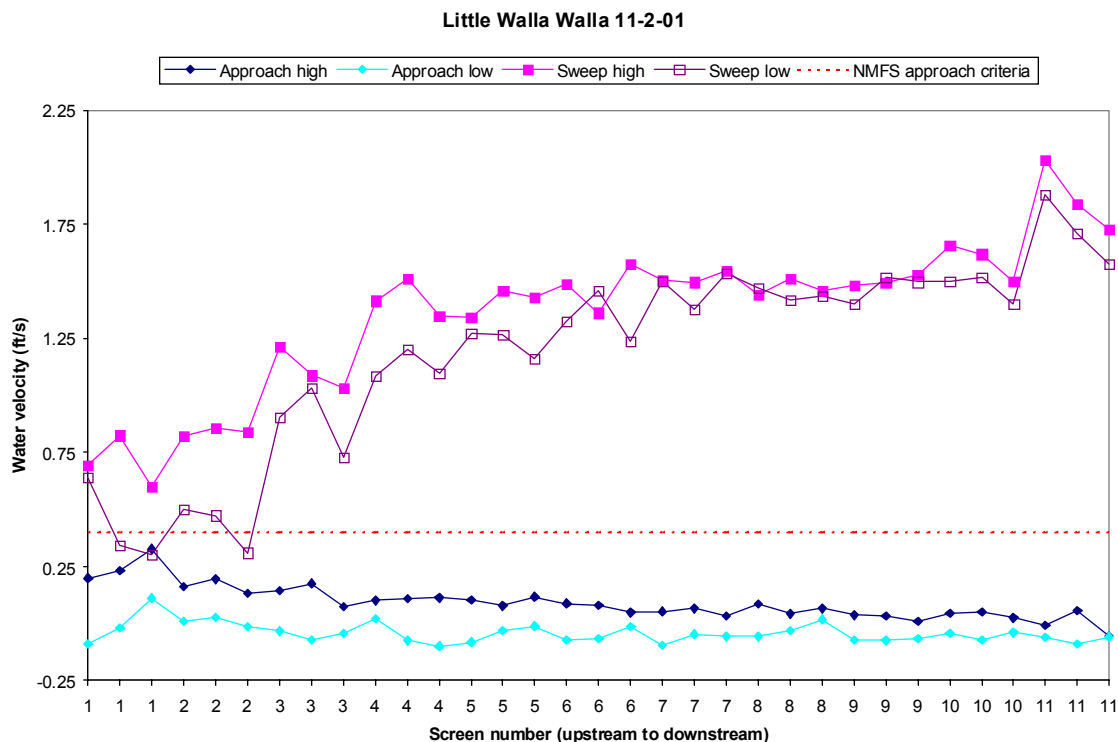
The flat plate screens at this site appeared to be in compliance with the NMFS approach velocity criteria (Table 1 and Figure 6); sweep velocities were always higher than approach velocities. Sweep velocity increased towards the bypass, and the bypass velocity was greater than sweep in front of screens.

Figure 6. Approach and sweep velocities at the Little Walla Walla River fish screen site on November 2, 2001. The red line at 0.4 feet/sec denotes the NMFS criteria for fish screen approach velocities.

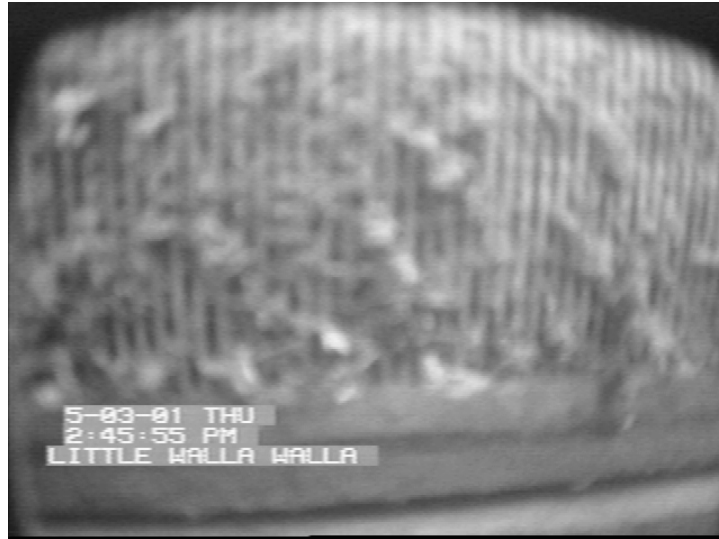
Sediment buildup was not a problem at this site, nor was accumulation of debris. The use of underwater video allowed us to evaluate the effectiveness of the automatic cleaning brushes at the Little Walla Walla site. In both May and June, there was substantial algae growth on the bottom six to 12 inches of the screen, indicating that the brushes were not functioning to their full potential (Figure 7). In addition, the brush cable was showing signs of wear (fraying).

Figure 7. Algae buildup and lack of caulking at the bottom of screen panel 11 of the Little Walla Walla River screen site on May 5, 2001.

site. These included lack of caulking at the bottom of the flat plate screens and excessive accumulation of debris at Burlingame. The lack of caulking creates gaps between the screen and the cement bottom of the forebay that could potentially harm fish, while debris build-up could create habitat for predators. The automated cleaning brushes at Little Walla Walla generally functioned properly; chains and other moving parts were well greased and operative. However, the cleaning brush was not effectively cleaning the lower portion of the screen surface at the Little Walla Walla site.

cleaning brush was showing signs of wear (cracks and frays) and should be replaced.

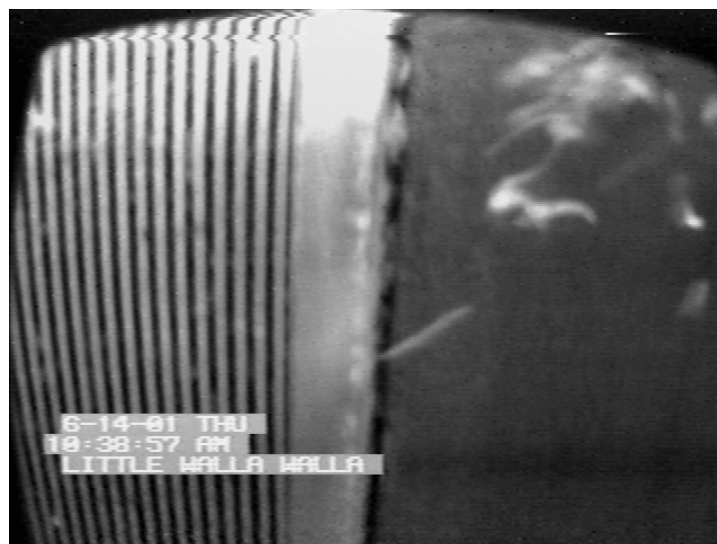
The screen material seemed to be in good condition during both visits. There was some headloss (1.25 inches) across the screen in June, but virtually none in May (0.25 inches). Some of the vertical seams between the screens were lacking caulking which created gaps that could potentially harm fish (Figure 8).

Figure 8. Gap at top of screen 3 upstream seal at Little Walla Walla.

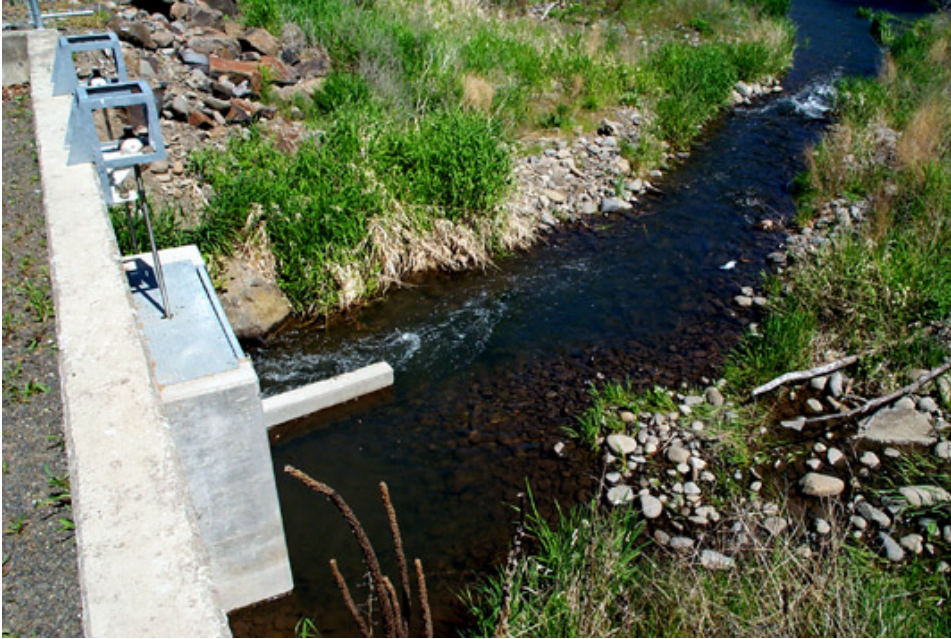
The bypass weir was not completely open either month, but water flowed freely over the top. The upstream portion of the bypass outfall at Little Walla Walla is piped, while the lower portion is an open channel (Figure 9). This site appeared to meet the minimum requirements set by the NMFS for in-pipe water depth, although the water in the open channel portion of the outfall at Little Walla Walla was less than 9 inches in some places in June.

Figure 9. Open channel portion of the bypass at the Little Walla Walla fish screen facility.
